Sumac Park and H.M.S. Plumper Park Overview

By: Haansen Christensen For: The Friends of North Saanich Parks (FNSP)

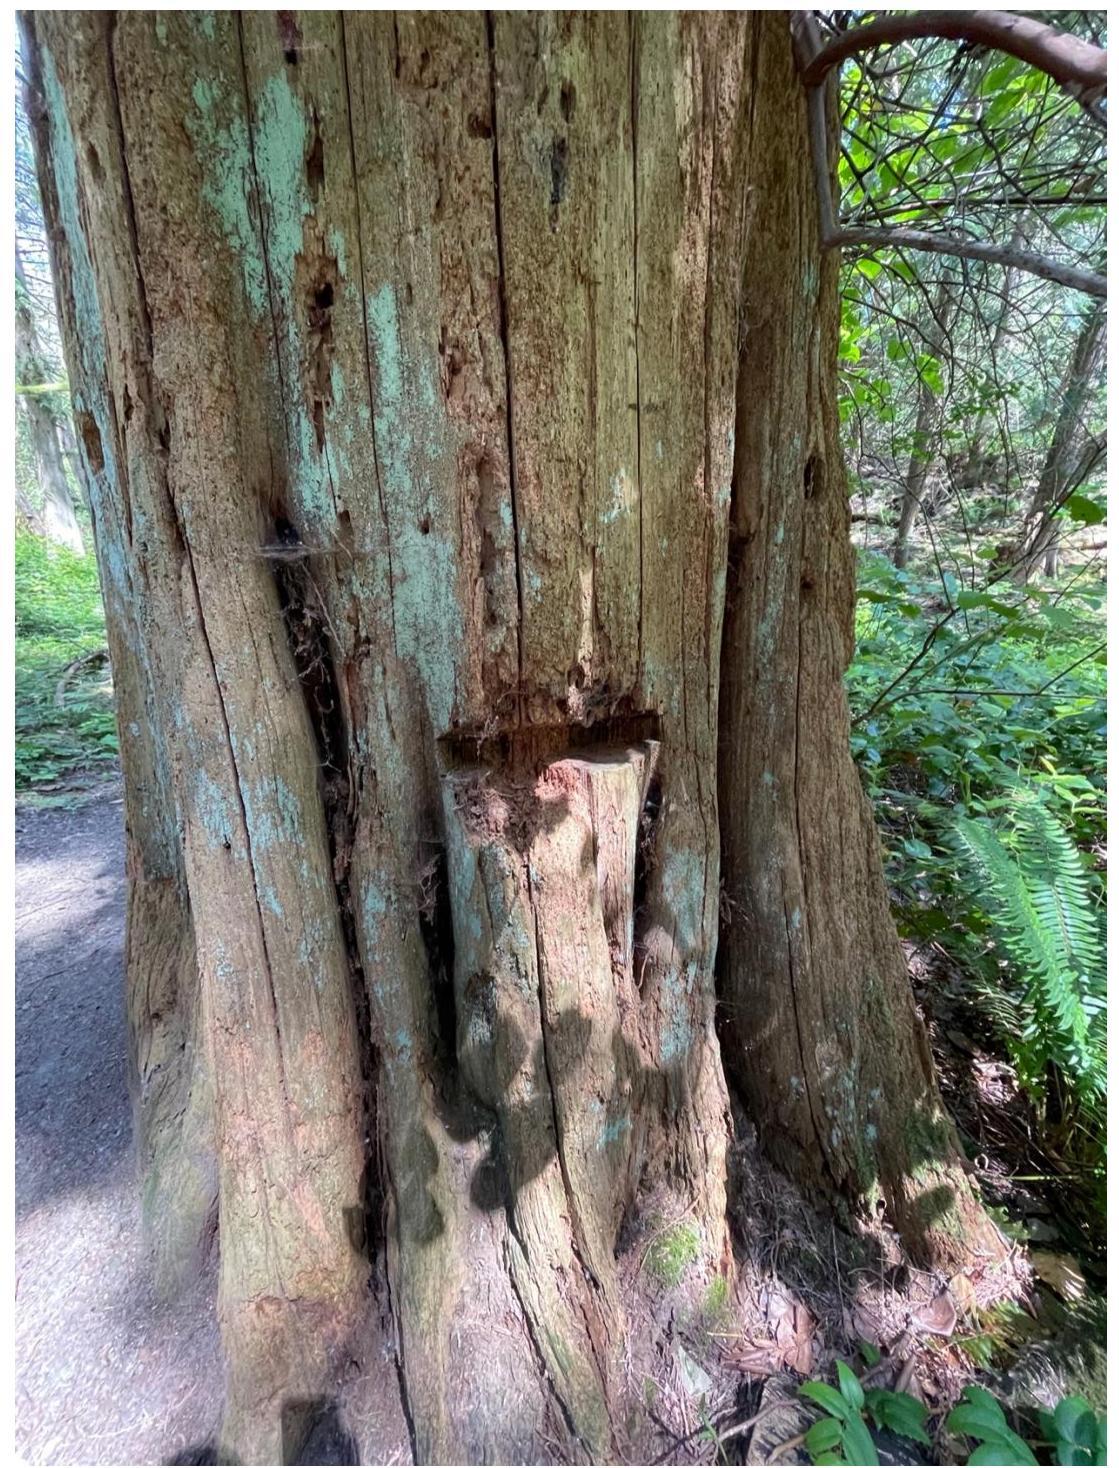
Figure 1: Springboard notch on a Western redcedar stump – evidence of prior logging.

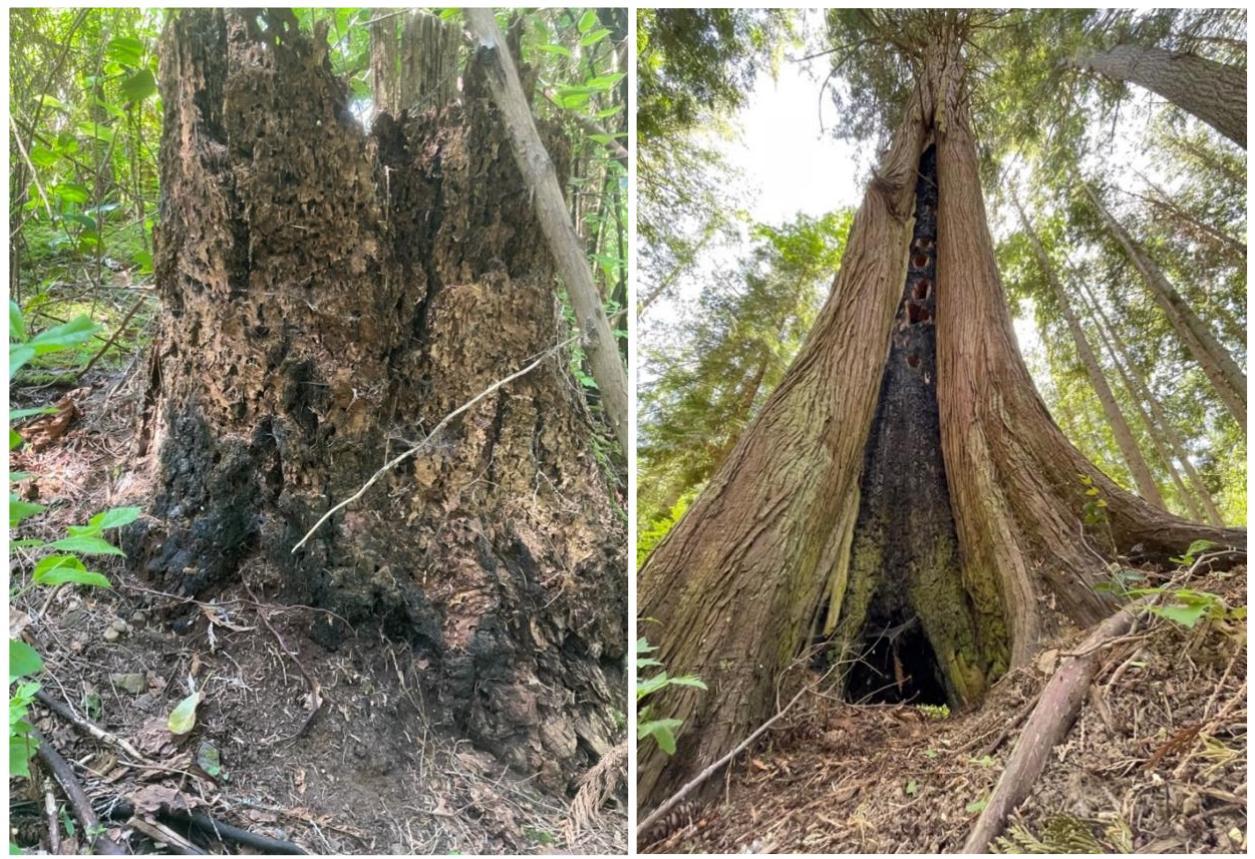
Figures 2 & 3: Fire scars found within Sumac Park on a Douglas-fir stump (left) and Western redcedar living tree (right).

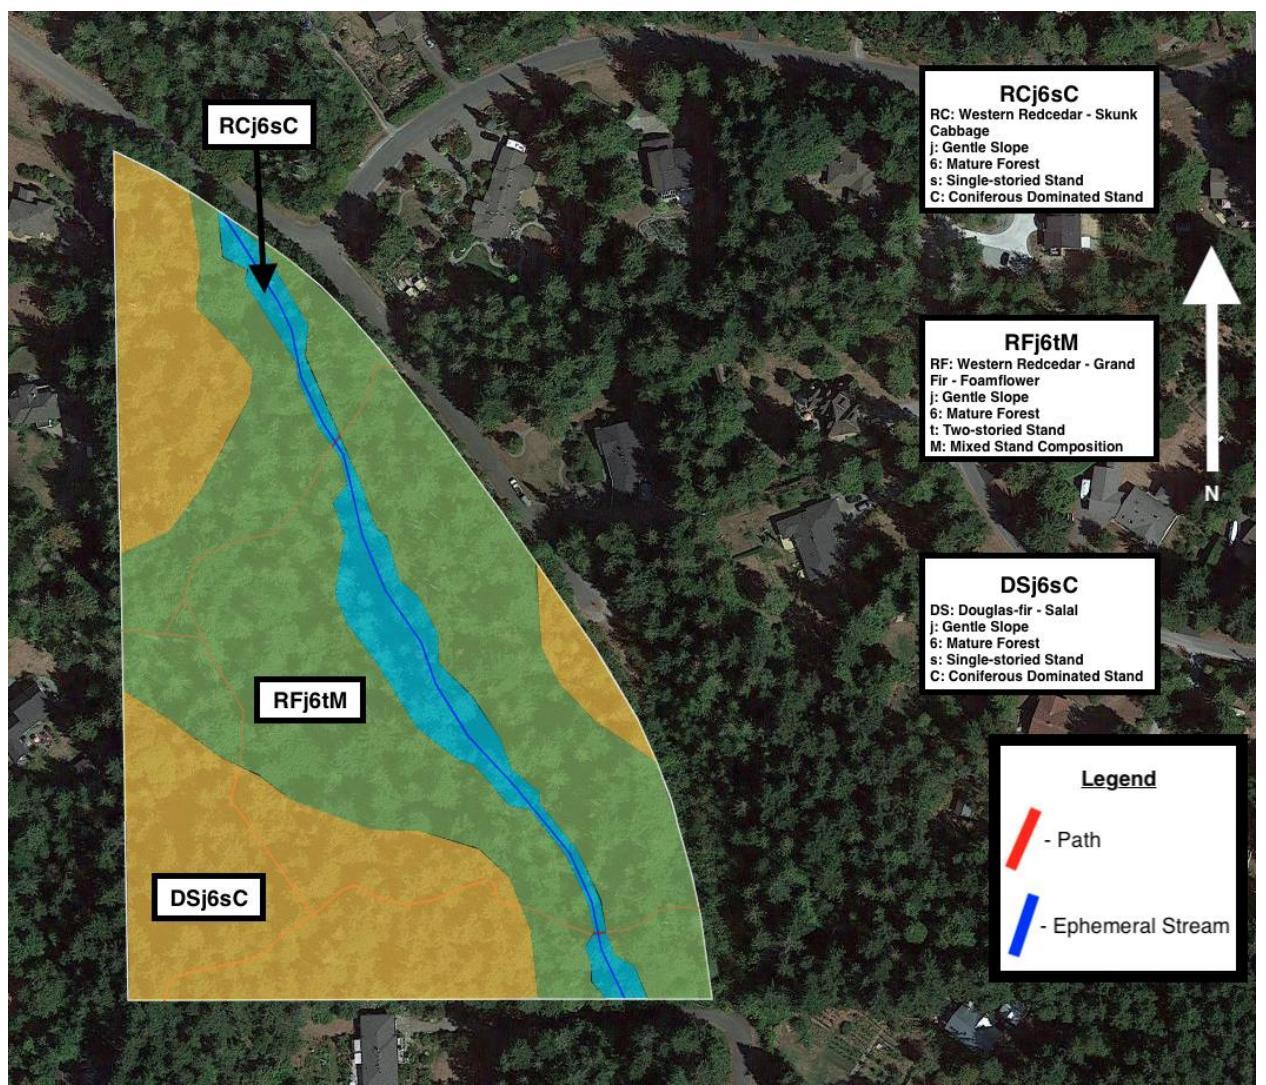
Figure 4. Map of Sumac Park and the plant/site associations found within.

At the bottom of the ravine where water is abundant, the site association of RCj6sC is found (Figure 4). This site association occurs in areas of poor drainage and is often found in topographical depressions (Madrone Environmental Services LTD, 2008). The plant community in a mature forest such as the one found in Sumac Park often consists of Western Redcedar (*Thuja plicata*), Western skunk cabbage (*Lysichiton americanus*), Salmonberry (*Rubis spectabilis*), and Lady Fern (*Athyrium filix-femina*).

At slightly higher elevations where water is slightly less abundant, the site association of RFj6tM is found (Figure 4). Within this site series, the plant community is often comprised of Western Sword Fern (*Polystichum munitum*), dull Oregon Grape (*Mahonia nervosa*), and Salal (*Gaultheria shallon*), with a canopy comprising mostly of Douglas-fir (*Pseudotsuga menziesii*) and Western Redcedar, in addition to Grand Fir (*Abies grandis*) and Bigleaf Maple (*Acer macrophyllum*).

At the highest elevations within Sumac Park where water is the scarcest, the site association of DSj6sC is located (Figure 4). The plant community in this site series within Sumac Park consists of thickets of Oceanspray (*Holodiscus discolor*) and Salal, as well as a canopy comprised of primarily Douglas-fir, Grand Fir, and the occasional Arbutus (*Arbutus menziesii*). The site association of DS (Douglas-fir – Salal) is representative of the climate for the CDFmm region as a whole (Madrone Environmental Services LTD, 2008).

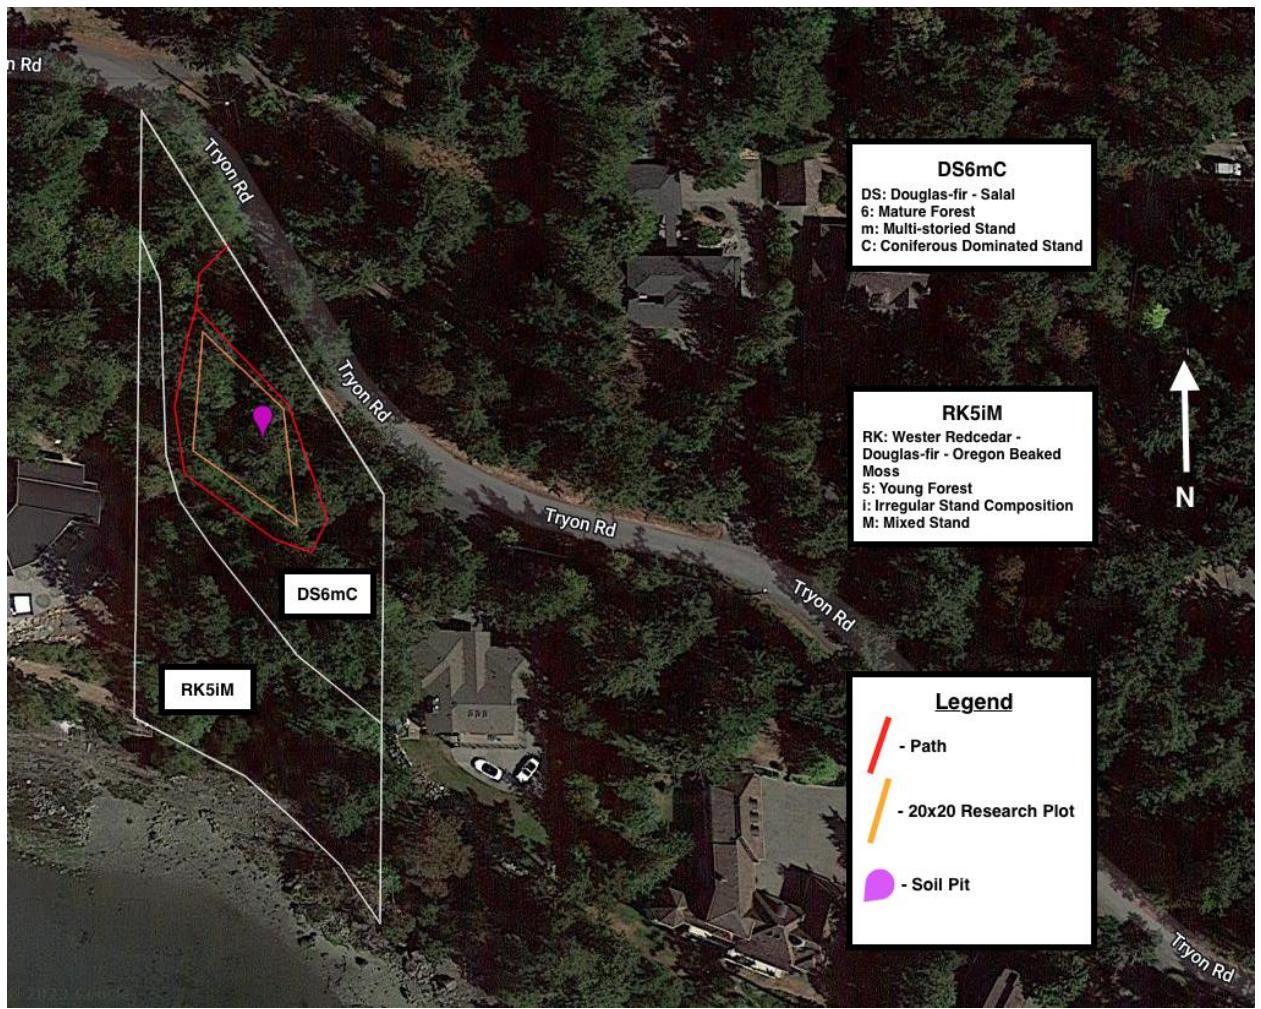
Figure 5: Map of H.M.S. Plumper Park and the plant/site associations found within.

As one enters the park from its highest elevation (13m ASL) at the north end of the park, the site association of DS6mC is found (Figure 5). This site association, similar to the DSj6sC site association situated on the upper slope of Sumac Park (Figure 4), is characteristic of drier sites where water is more readily lost (Madrone Environmental Services LTD, 2008). In H.M.S. Plumper Park, this site association hosts Douglas-fir, Salal, Oceanspray, and Western Redcedar.

The other site association found in H.M.S. Plumper Park is found at the lower reaches of the park as it slopes down to the ocean, being RK5iM. This site association is found in moisture-receiving areas, typically on the lower portion of gentle slopes (Madrone Environmental Services LTD, 2008). The plant community consists of Grand Fir, Red Alder (*Alnus ruba*), and Salal, with other moisture-loving species such as Willow (*Salix sp.*) and Common Horsetail (*Equisetum arvense*) found within this area.

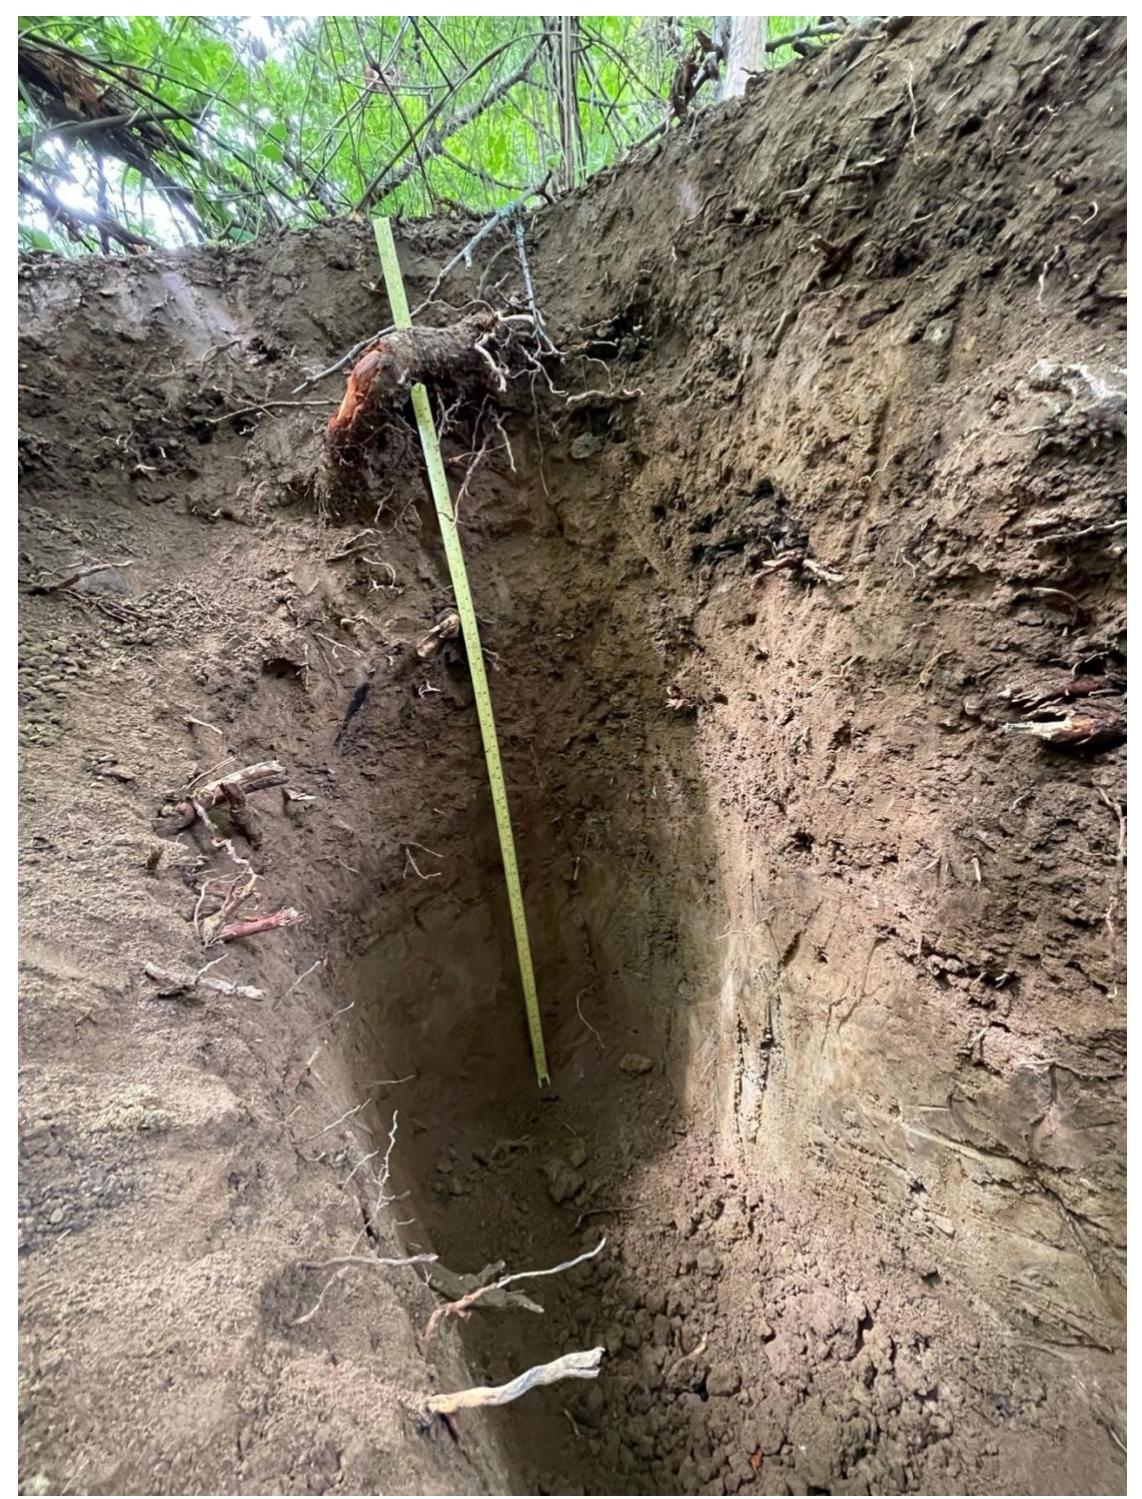
The soil found at H.M.S Plumper Park is classified as GL.SB (Gleyed Sombric Brunisol) due to the thick and dark-coloured Ah horizon and the presence of mottling in the C horizon attributing it with the modifier "g" (The Canadian System of Soil Classification, 1998). This mottling, as well as the gentle slope of the site, are indicative of imperfect drainage. Understanding the soil composition and characteristics allows us to better understand the plant community, hydrology, and nutrient cycling occurring in the park. The results of the soil analysis are summarized in Table 1 and photos of the soil pit can be seen in Figures 7-9.

Figure 7: Interior view of the soil pit at H.M.S. Plumper Park.

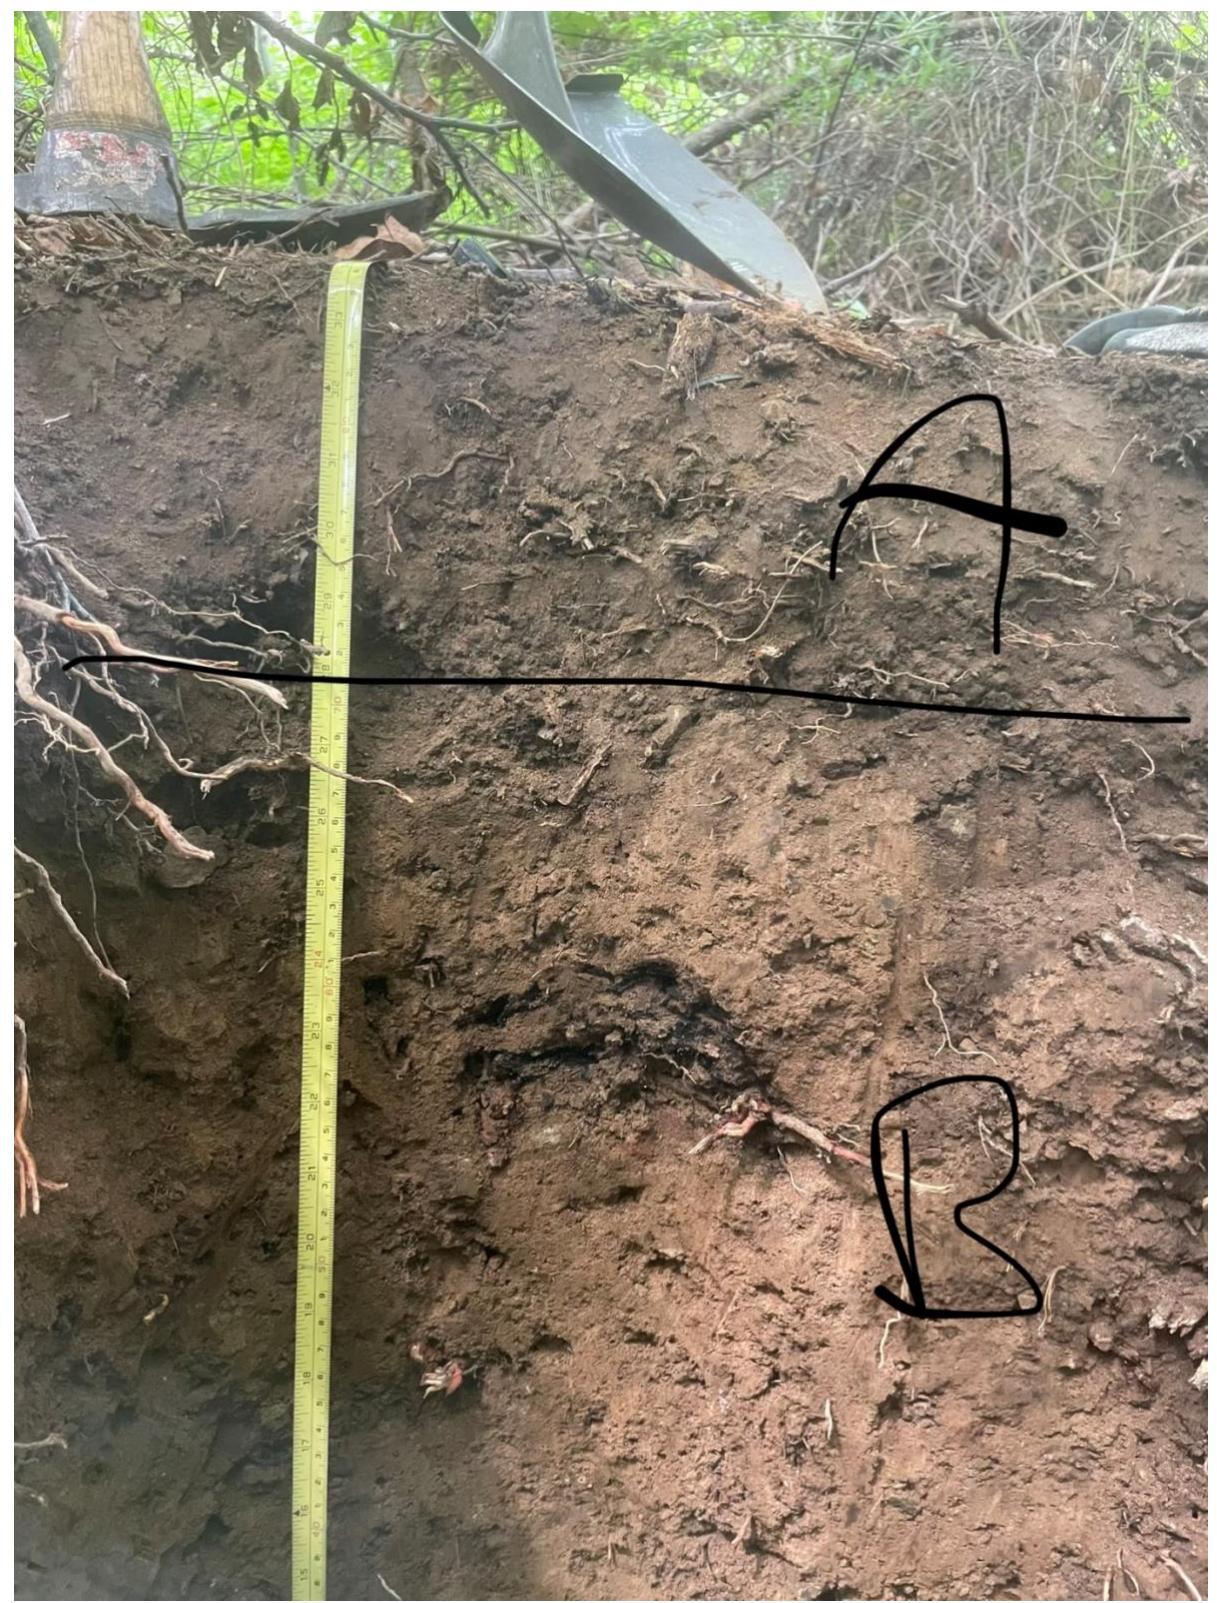
Figure 8: Boundary between the Ah and Bm horizons at H.M.S. Plumper Park.

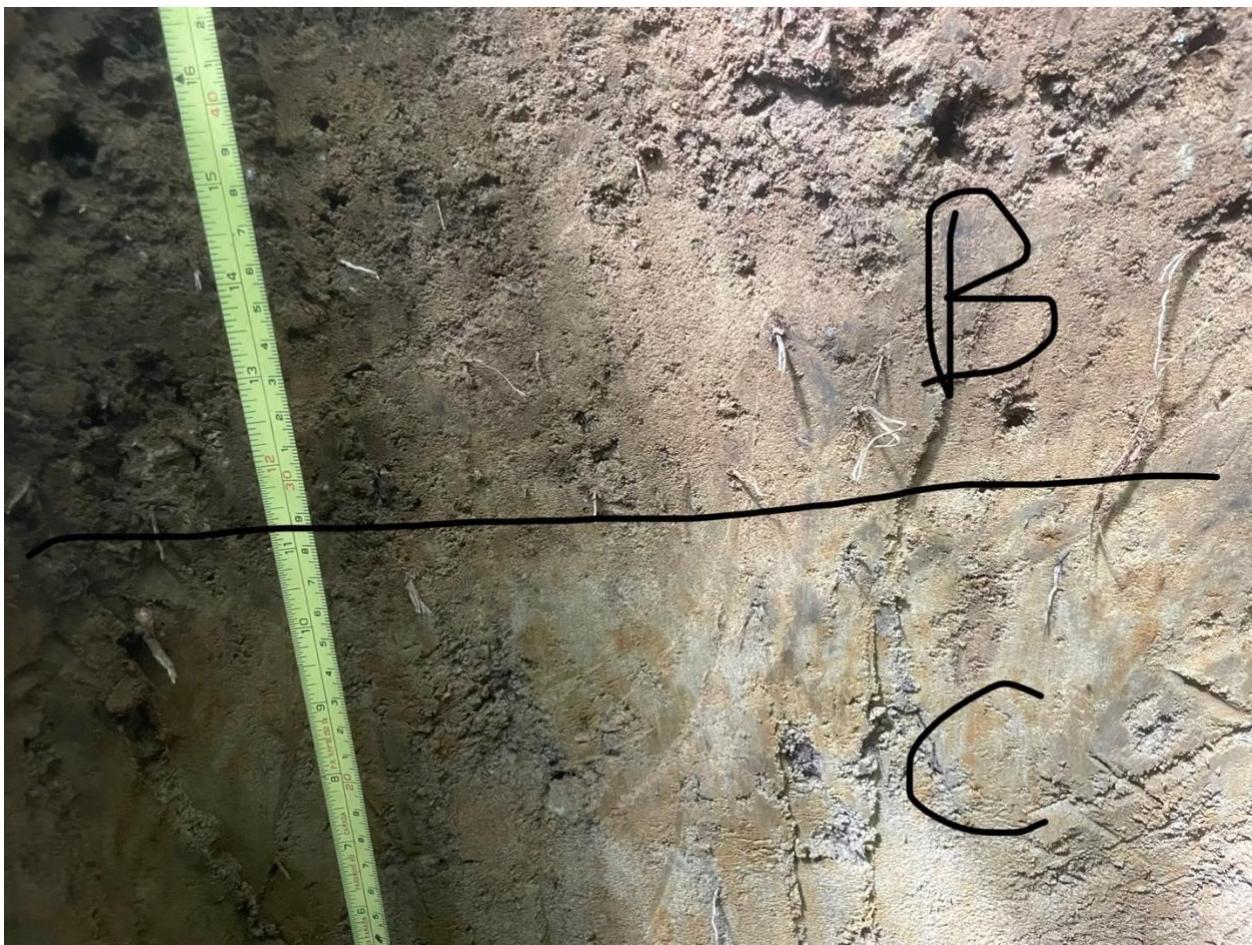
Figure 9: The boundary between the Bm and Cg horizons at H.M.S. Plumper Park.
